Reference Manual

Troubleshooting an Enphase Microinverter System

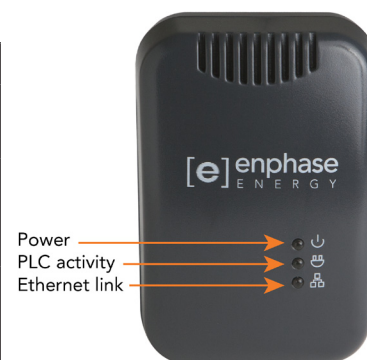
Use the status lights to verify connections. The table below describes the lights on the front panel of the unit.

Indicator	State	What it means
Power	On	Indicates device powered on
	Off	Indicates no power
PLC Activity	Blinking	Indicates activity on power line
	Off	Indicates no activity on power line (should blink intermittently)
Ethernet Link	On	Indicates Ethernet connectivity
	Blinking	Indicates Ethernet traffic
	Off	Indicates no Ethernet activity

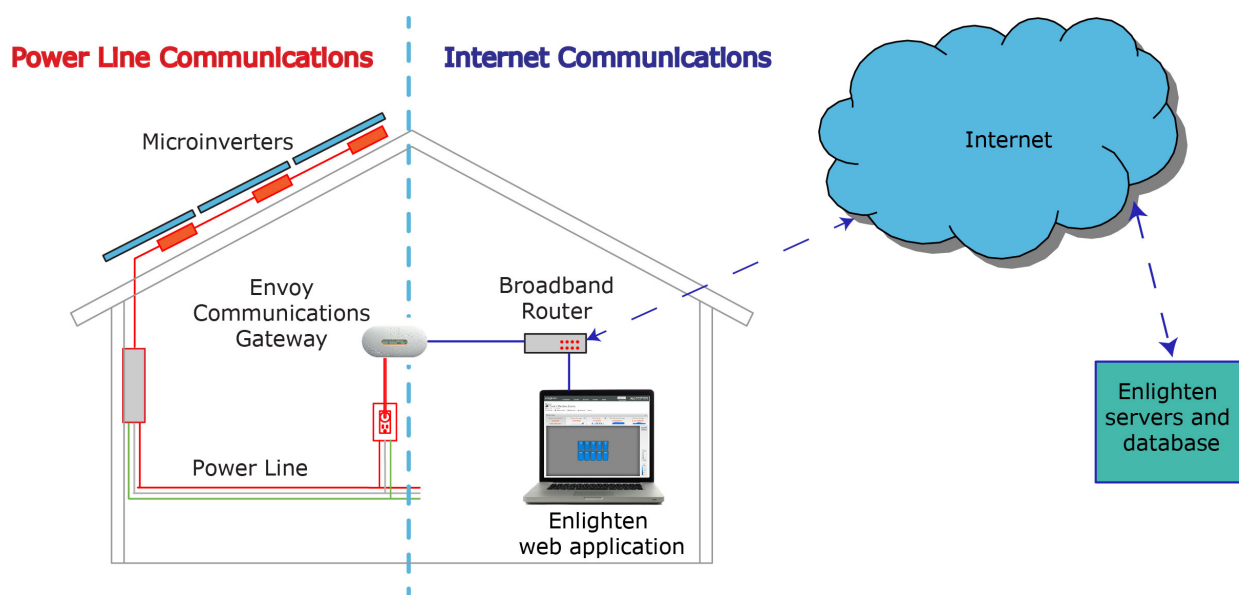
Power line communication between the Envoy and the microinverters is completely separate from the Envoy Internet communication. That is what makes the Envoy a "gateway device". One side of the Envoy communicates with the microinverters via the power lines. The other side of the Envoy communicates with the Internet using a standard Ethernet/network cable plugged into your broadband router.
